HA-409

William F. Bayless House
3700 Blk. Harmony Church Road
Darlington vicinity
Private

INVENTORY FORM FOR STATE HISTORIC SITES SURVEY

William F. Bayless House

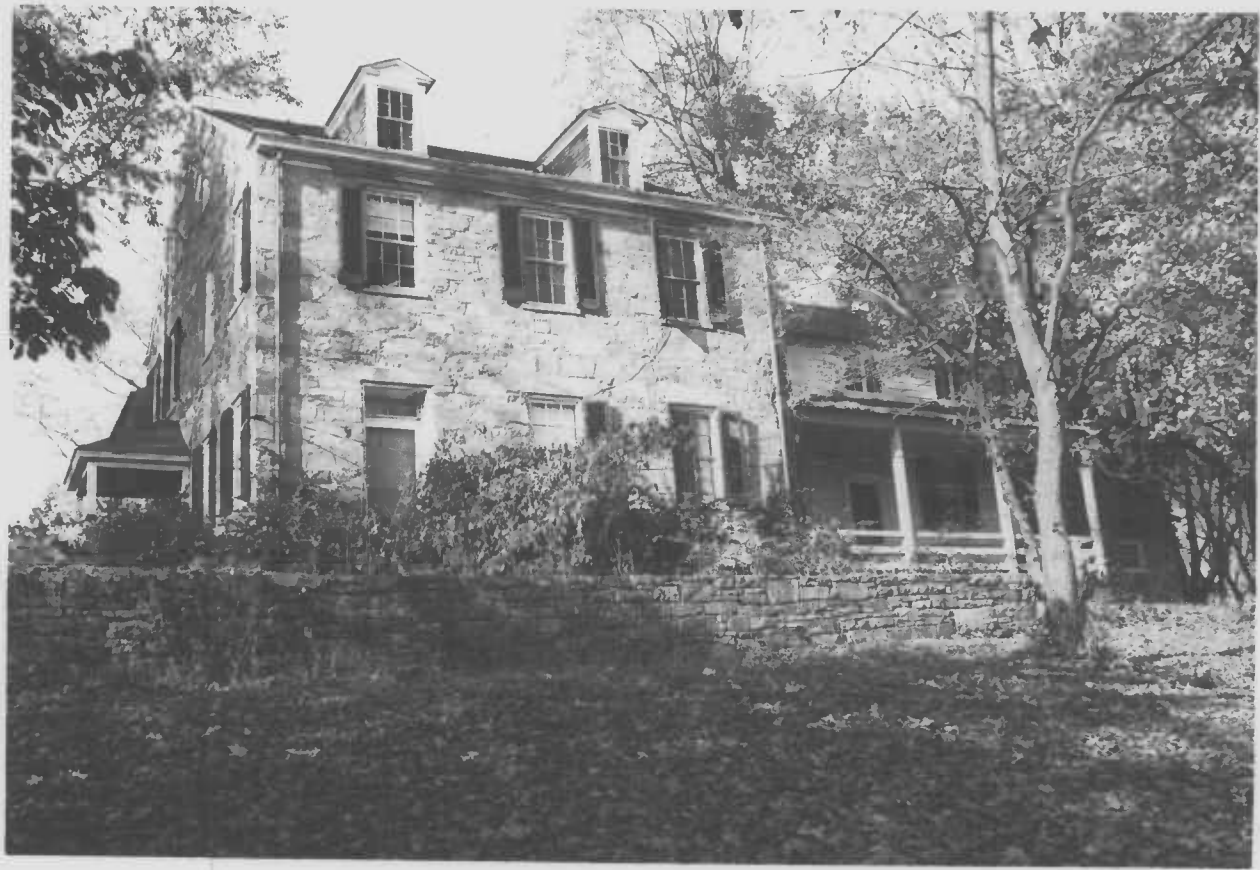
William F. Bayless House HA-409
Harford County
Photo: Janet Davis
November 1982
South elevation

The main section of the Bayless House is a two-story gable-roofed rubble-stone structure with a three-bay main elevation facing south. The entrance is in the west bay and has a simple frame with a rectangular transom. Two slate-sided dormers with gable roofs project from the slate roof on this elevation. The main section has a four-bay west elevation with the present main entrance in the north inner bay. This entrance has a small shed entry porch. The windows in the main section are six over six sash and most windows have louvered shutters. A datestone inscribed "1844" is located in the east gable.

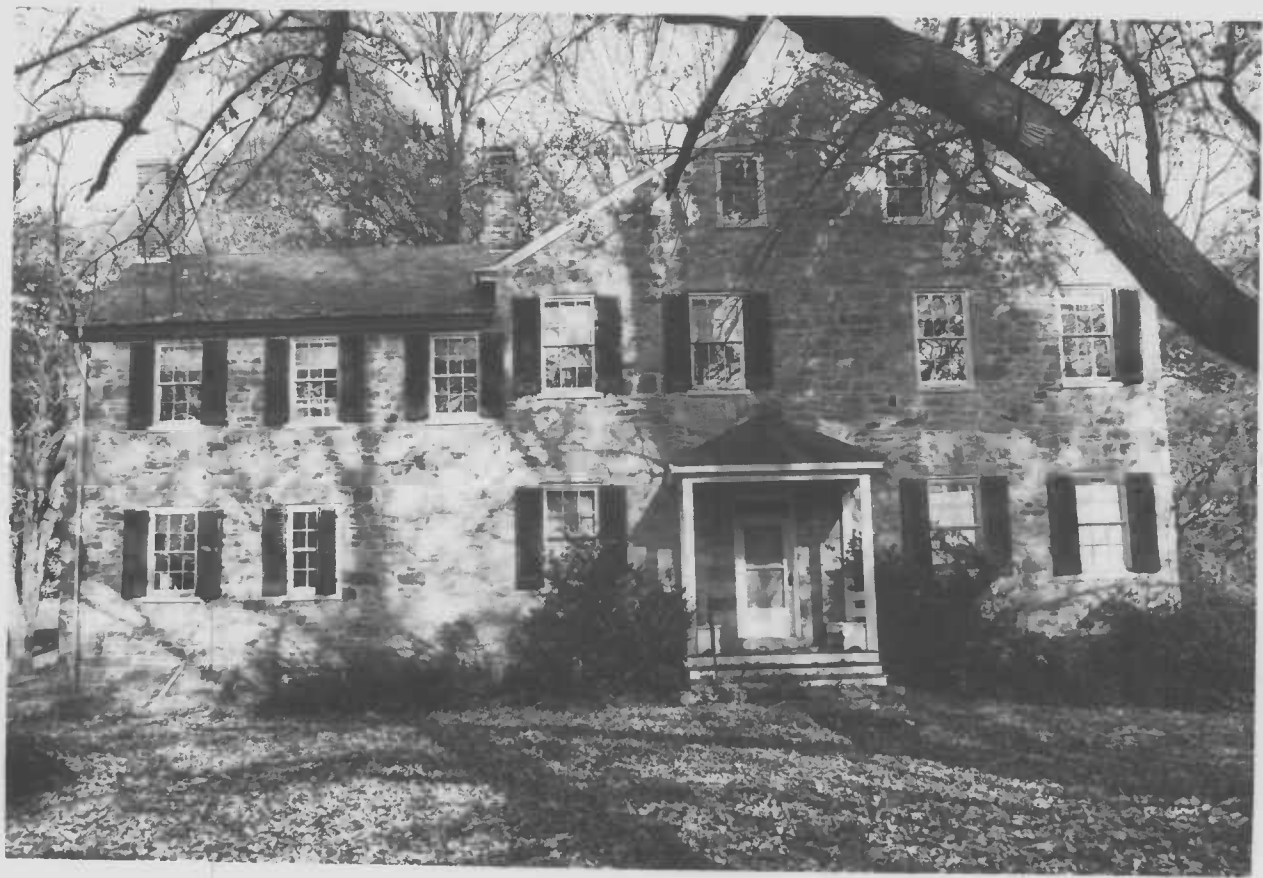
William F. Bayless House

West Elevation

Extending north from the main section is a two story stone wing, containing an interior end chimney on the north. This may be the oldest section of the house, following the common custom of building a small house and adding a larger and finer main section at a later time. The wing has a door in the two bay east elevation.
